# **EXHIBIT D**

# Lead Cable Investigation

June 30, 2023

Marine Taxonomic Services, Ltd.  
Below the Blue 501(c)3

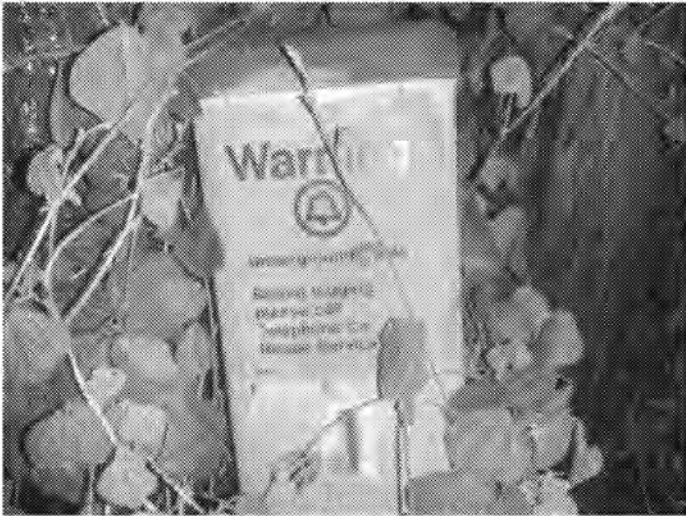
(A) Bell Systems sign for underground Telephone Cables. BL 2.1, Labadieville, Louisiana. June 2022.

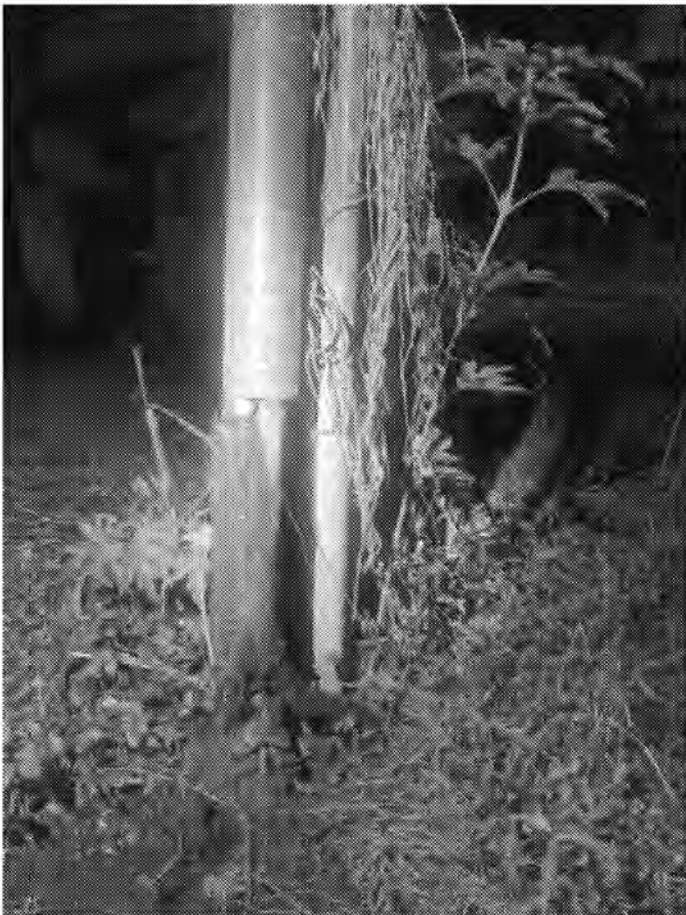
(B) Old telephone pole with cable guard and old conduit where a cable would have been. There is currently corrugated plastic hose behind the guard and in the steel pipe, but no visible cable. BL 2.2, Labadieville, Louisiana. June 2022.

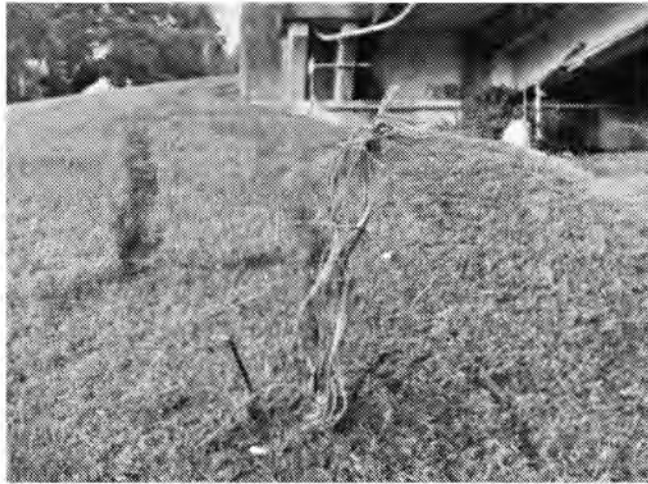
(C) Remnants of bare lead sheathed cable and steel wire below the Bridge Street Bridge. BT 1.1. June 2022, New Iberia, Louisiana.

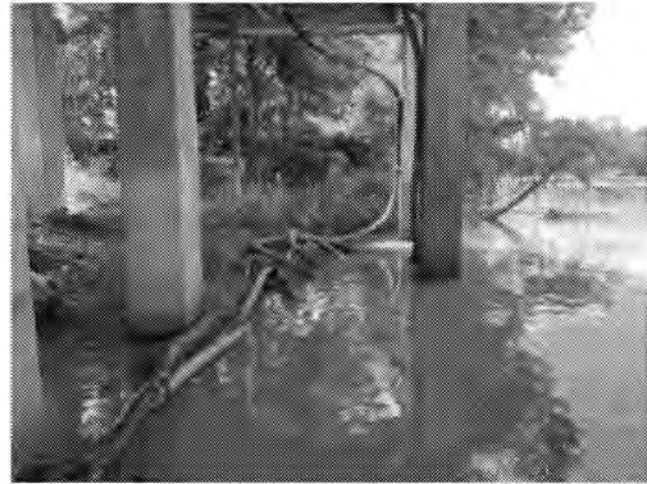
(E) Rd. 320 southeast of New Iberia, LA. Cluster of lead sheathed cables under the Oliver Bridge. BT 17.1. June 2022, New Iberia, Louisiana.

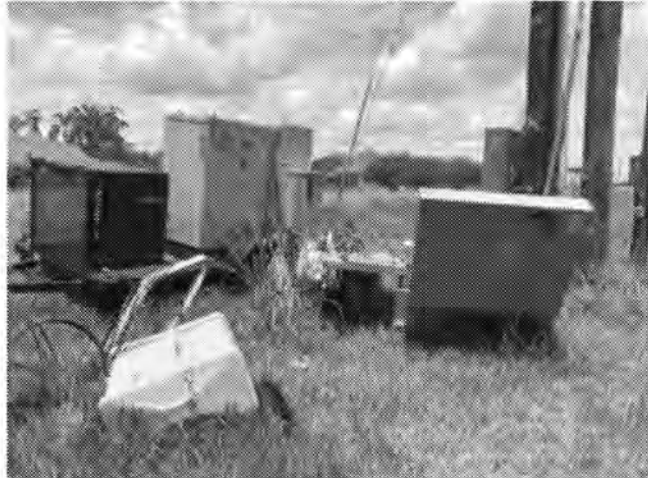
(D) Equipment debris field left by workers near the N Lewis Street Bridge. BT 16.1 June 2022, New Iberia, Louisiana.

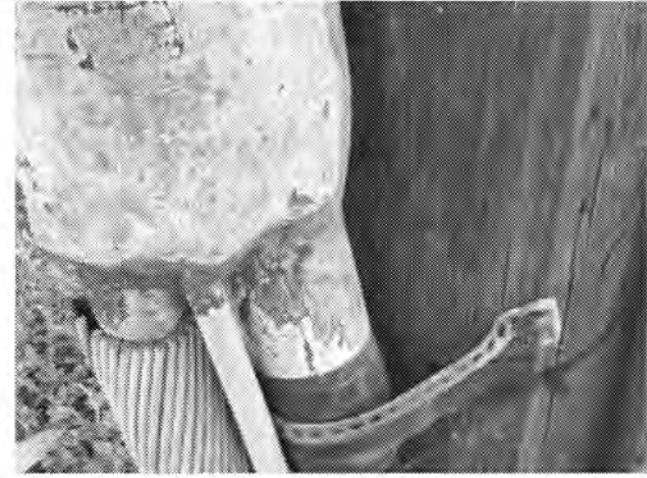
(F) Up close photo of bare lead sheathed cables coming from the bottom of a lead splice box (upper left corner of photo). BT 24.1. June 2022, St. Martinville, Louisiana.

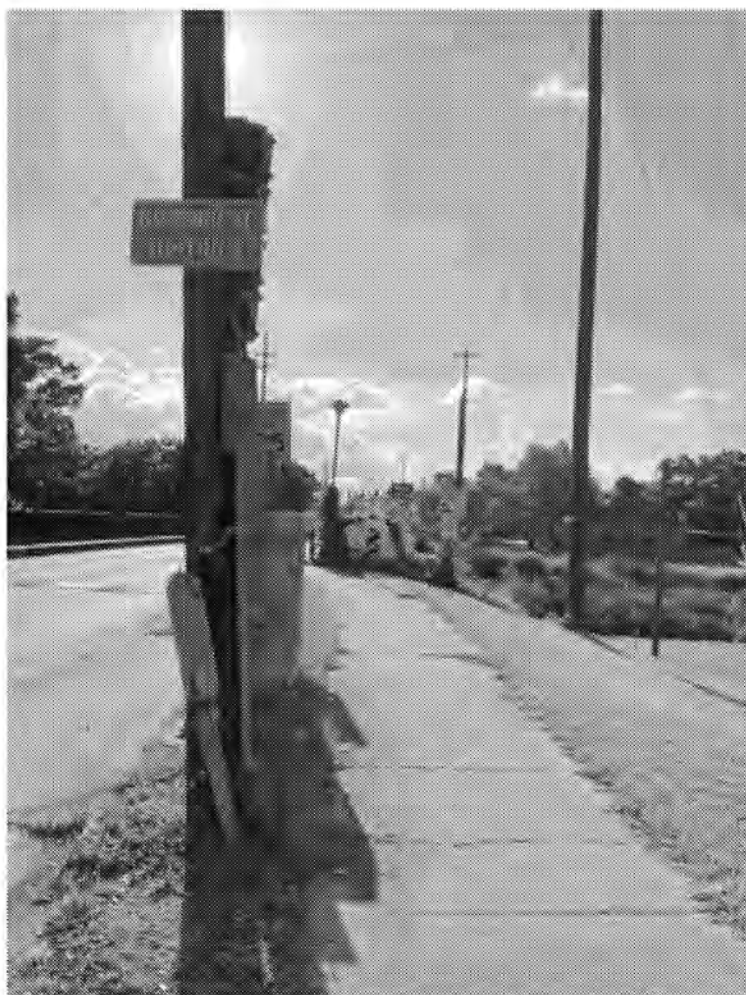
(G) Bare lead sheathed cables going into a lead splice box near the sidewalk leading into the Historical District. BT 24.1. June 2022, St Martinville, Louisiana.

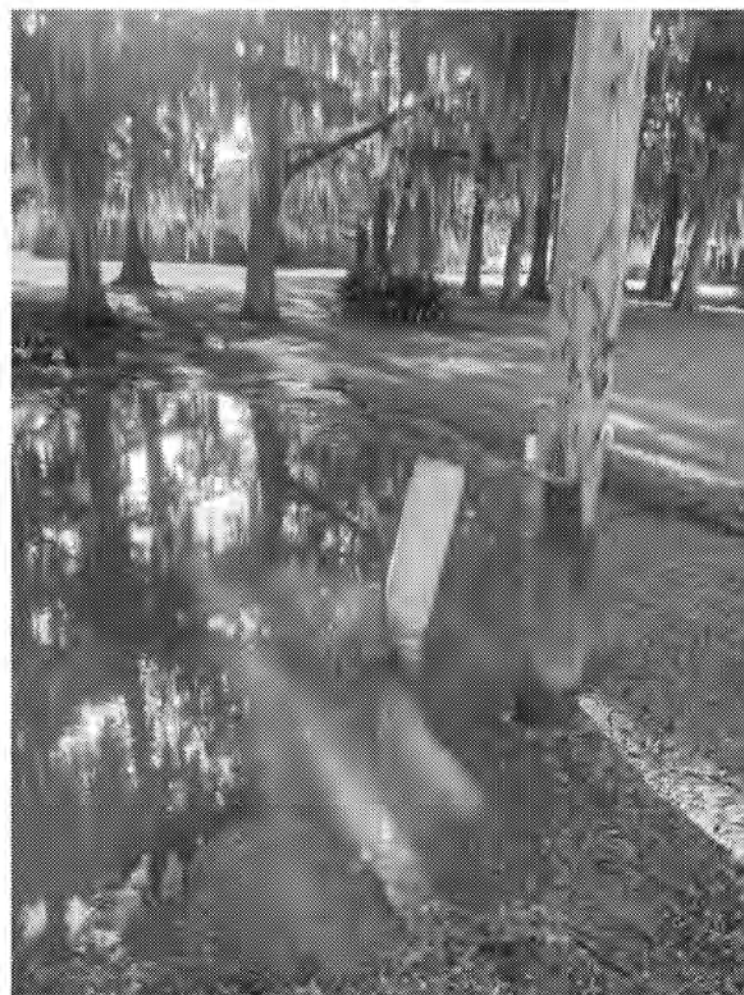
(H) Exposed lead splice box with attached cables and drainage into the Bayou Teche. BT 26.2. June 2022, Franklin, Louisiana.

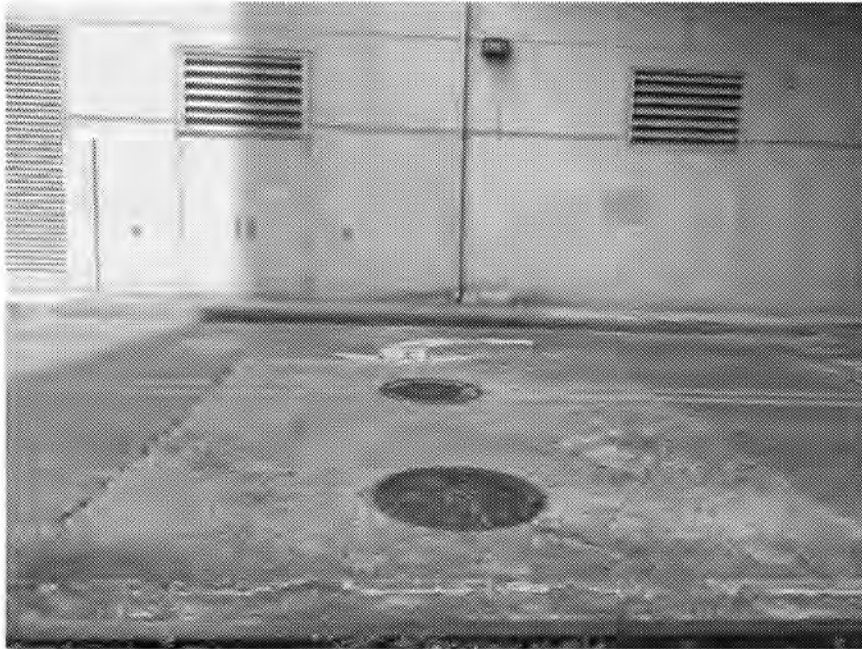
(I) New Orleans, LA. MISS 2.1 with Bell Systems manholes, vault, and Utility Building. This is a likely hub and splice area for cables, both old and new. June 2022.

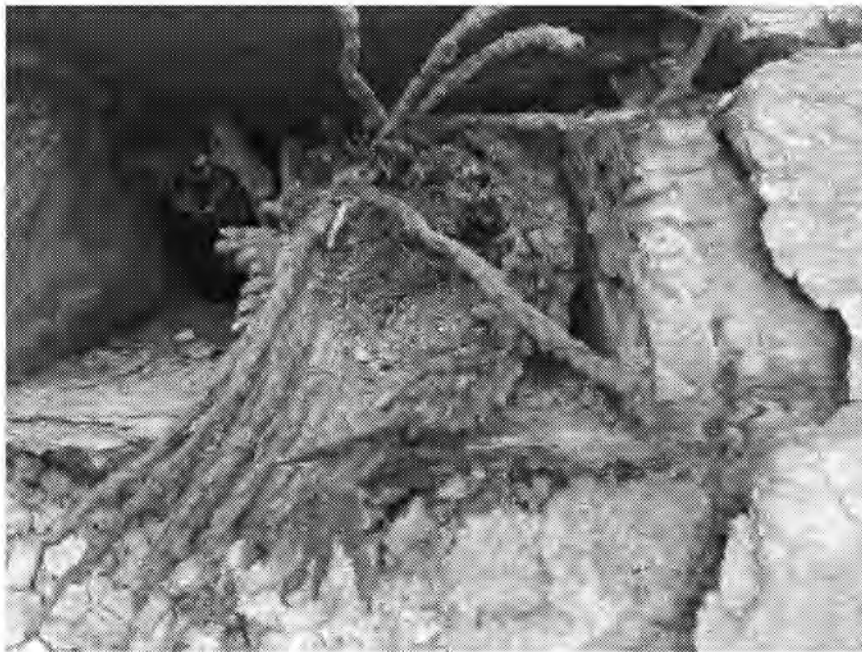
(J) New Orleans, LA. MISS 3.1, is an abandoned collection of cables.

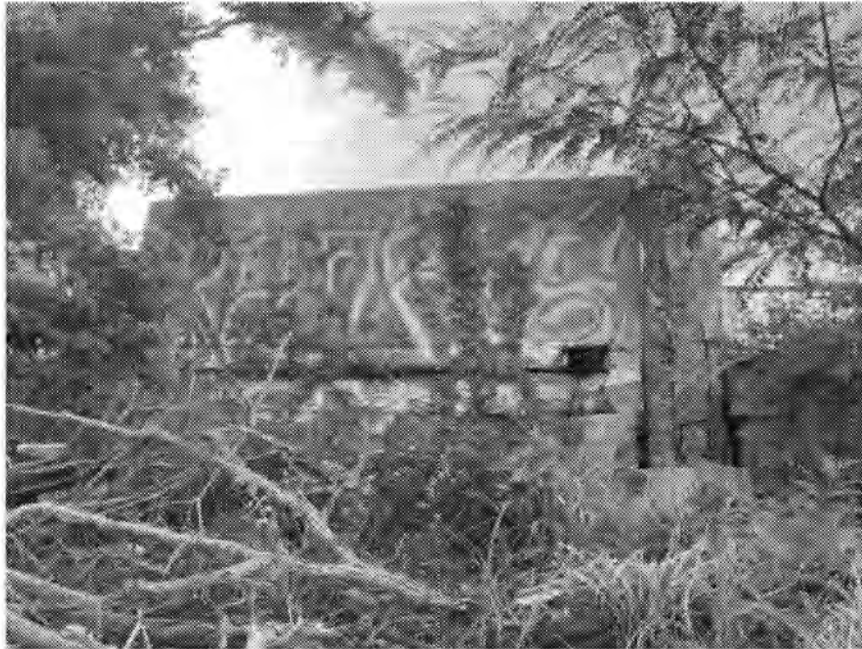
(K) New Orleans, LA. MISS 3.1. The small rectangle on the left is the passthrough for utility cables. June 2022.

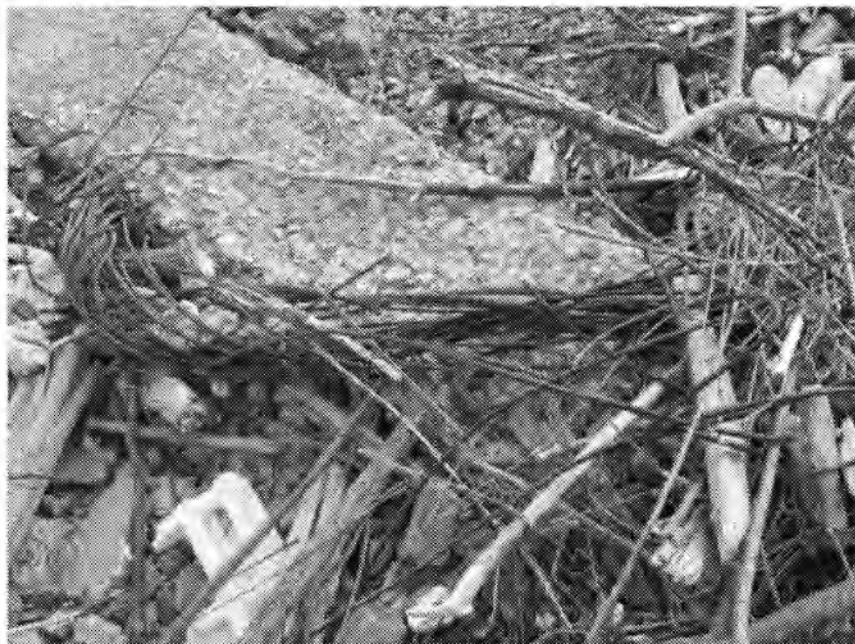
(L) New Orleans, LA. MISS 3.1. Remnants of outer steel wire from a lead sheathed cable. Evidence that parts of the cable may have been scrapped for money. Locals told us that that was done to these cables.

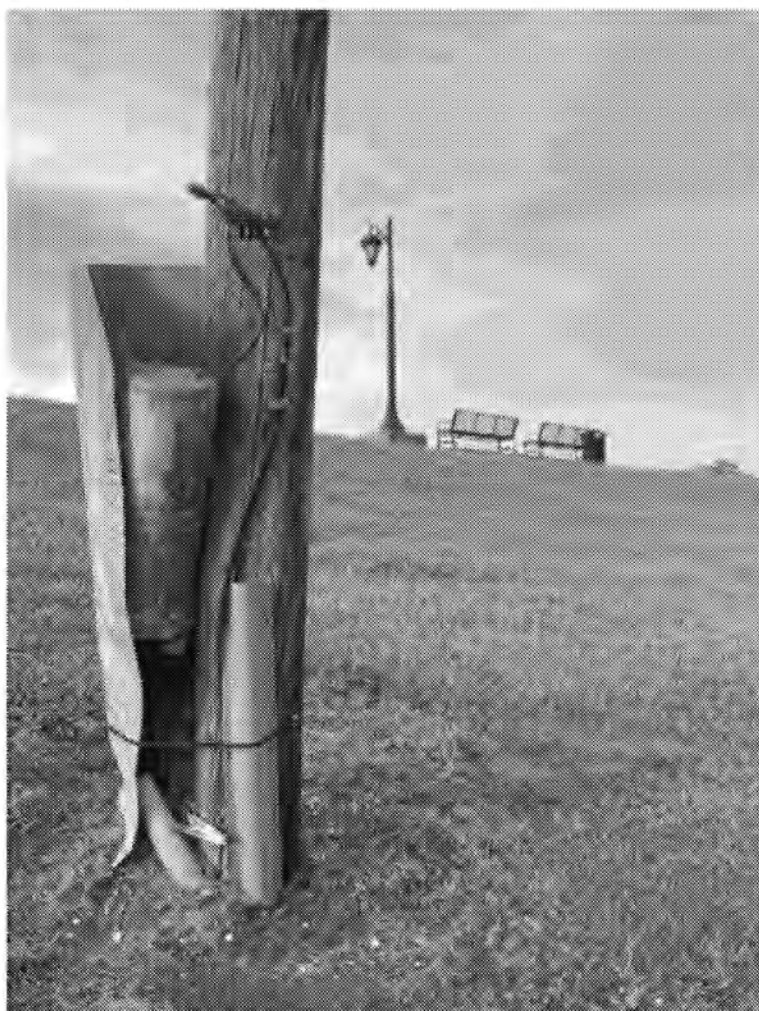
(M) Donaldsonville, LA. Location MISS 12.1. Exposed leaded splice box that appears to still be connected to an air test line. See photo (L) for the abandoned cable just the other side of the splice box. June 2022,

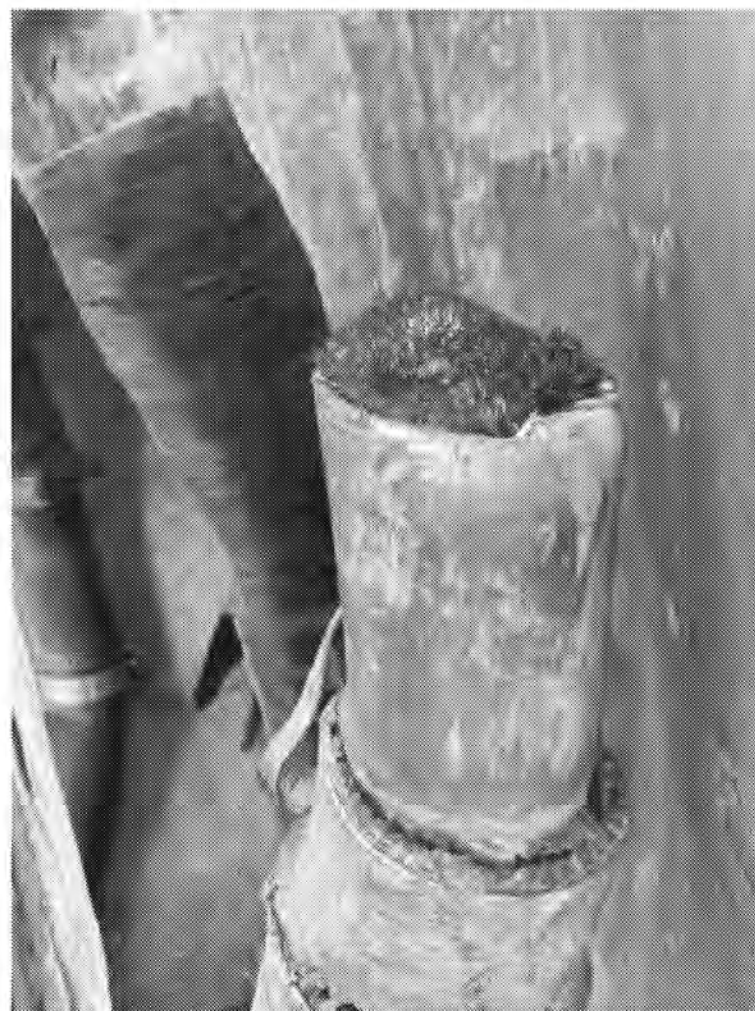
(N) Donaldsonville, LA. Location MISS 12.1. Close up of lead sheathed cable next to lead splice box seen in (K). June 2022.

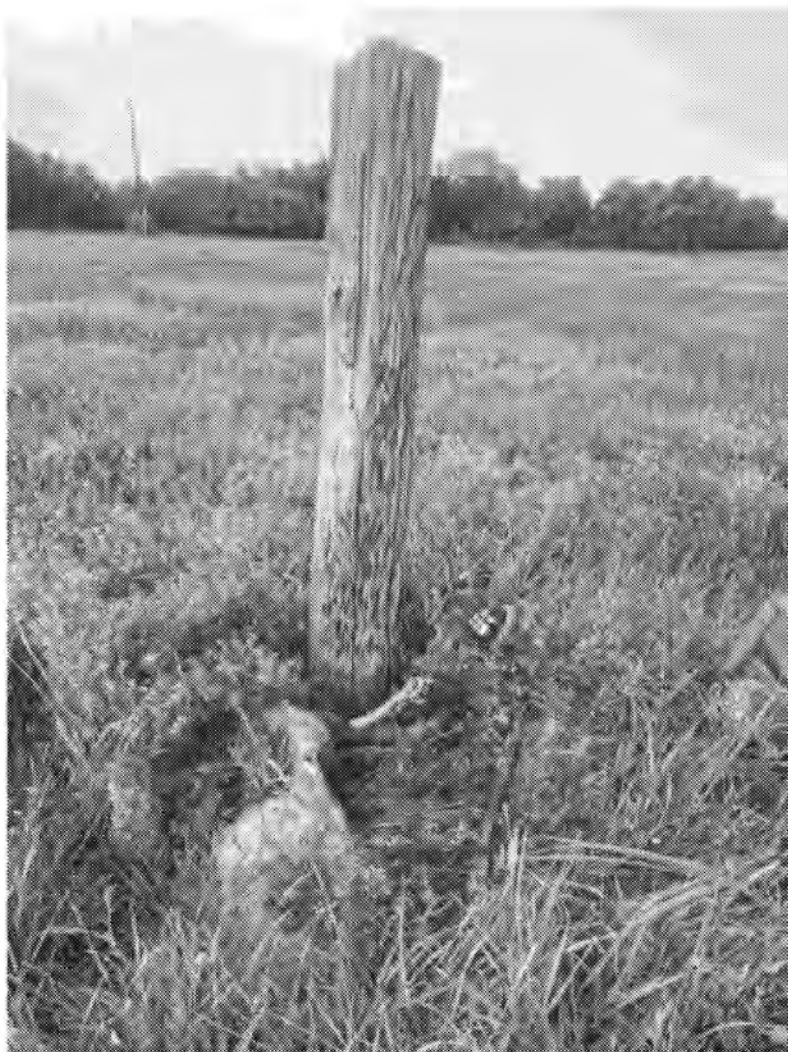
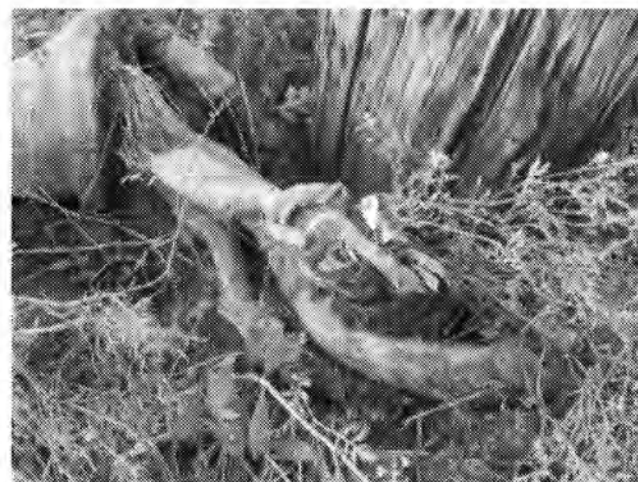
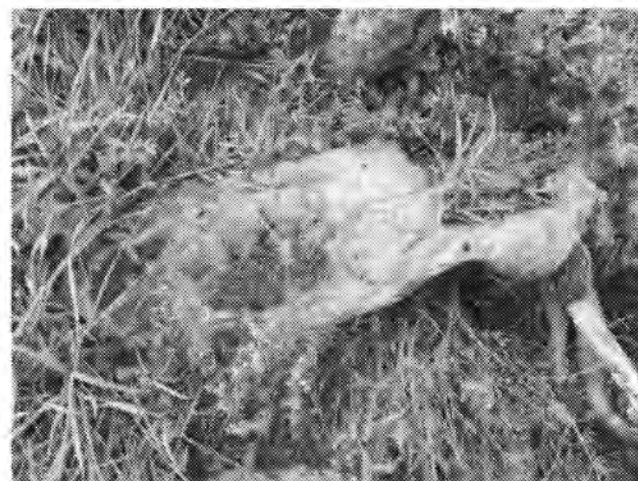
Figure 9 Photos. Louisiana continued. Damaged and abandoned leaded splice box and collection of five lead sheathed cables. MISS 12.3, June 2022, Donaldsonville, Louisiana.

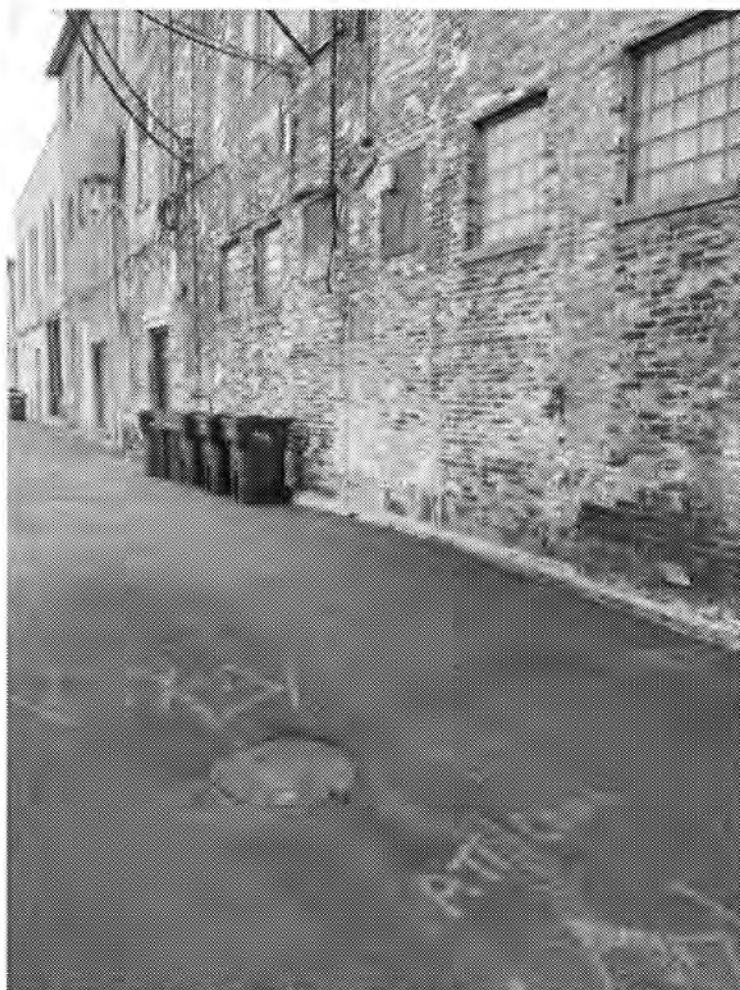
(A) Paint Markings indicating an AT&T service corridor. The lead sheathed test line follows these markings along the brick building shown above. LH 2.2, July 2022, Bay City, MI.

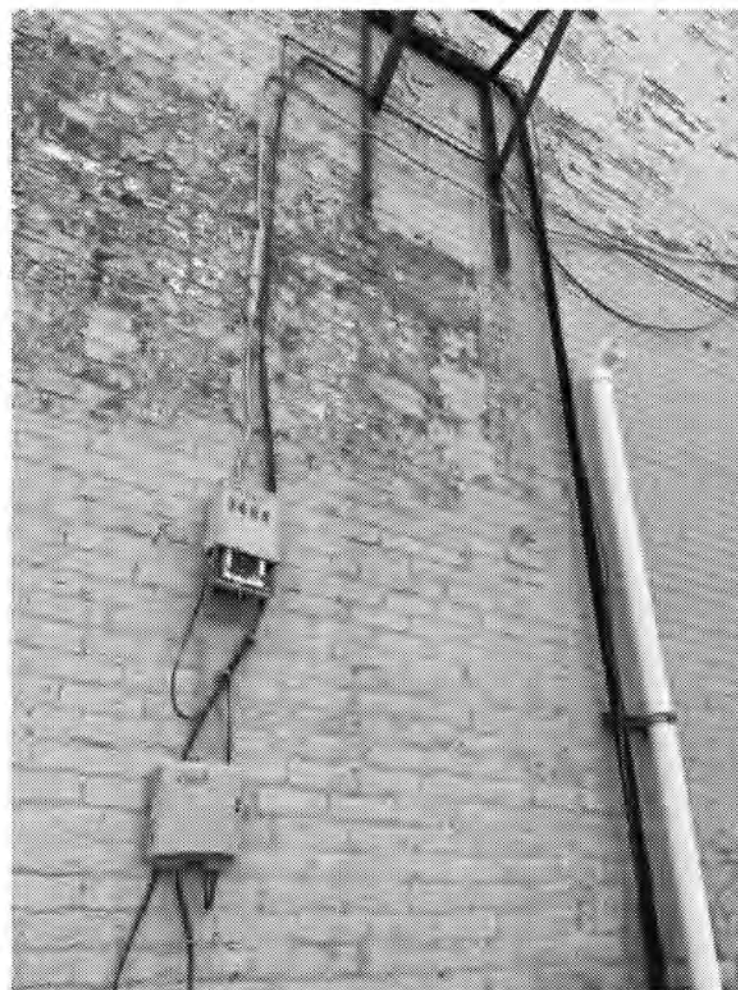
(B) End of the lead sheathed test line shown in (A). LH 2.3, July 2022, Bay City, MI.

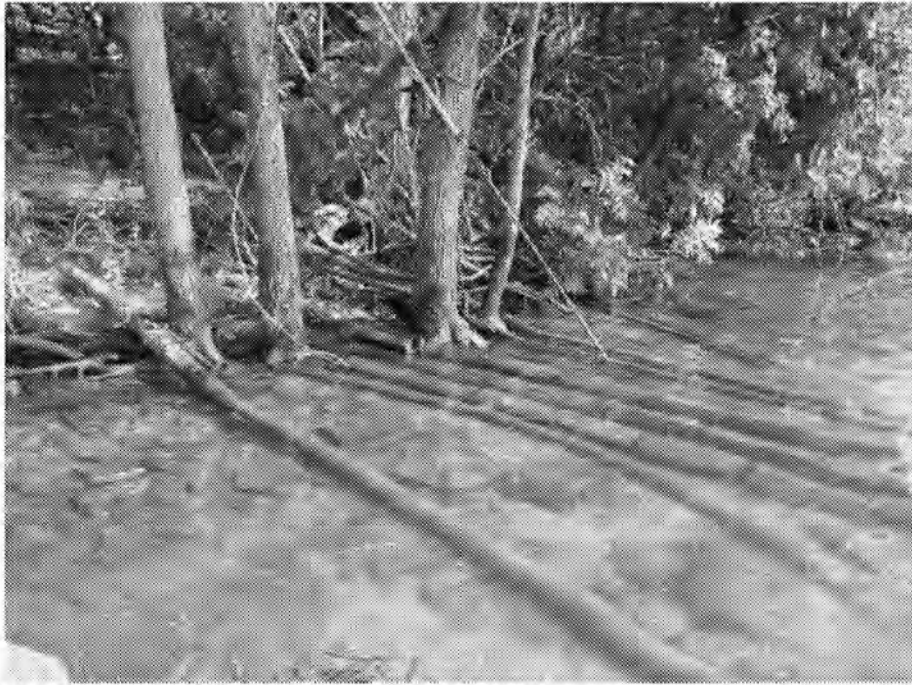
The only two locations in the screening areas contain visible lead sheathed cables along the Detroit River. At Location DR 1, there were seven cables along the shoreline and two Bell Systems manholes near the road (Figure 11(C-D)). The other location with a single cable hanging from the bridge and going into the water was found at site DR 2 (Figure 12(E-F)). The cable was cut and clearly abandoned in place. DR 3 was a sampled water intake location. For additional information, refer to details in the report titled "202207727 Michigan Data Collection – Final".

(C) Seven lead sheathed cables in the Detroit River. DR 1. July 2022, Trenton, MI.

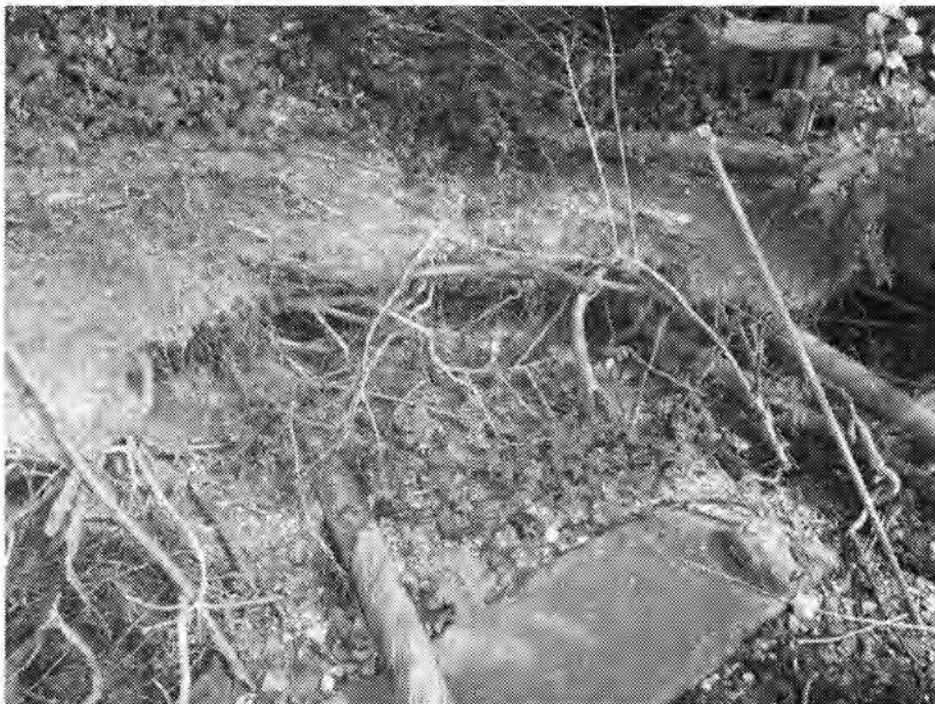
(D) Lead sheathed cables from (C) continuing past the tree line. They are buried in the ground and run up the hill to a Bell Systems manhole. DR 1. July 2022, Trenton, MI.

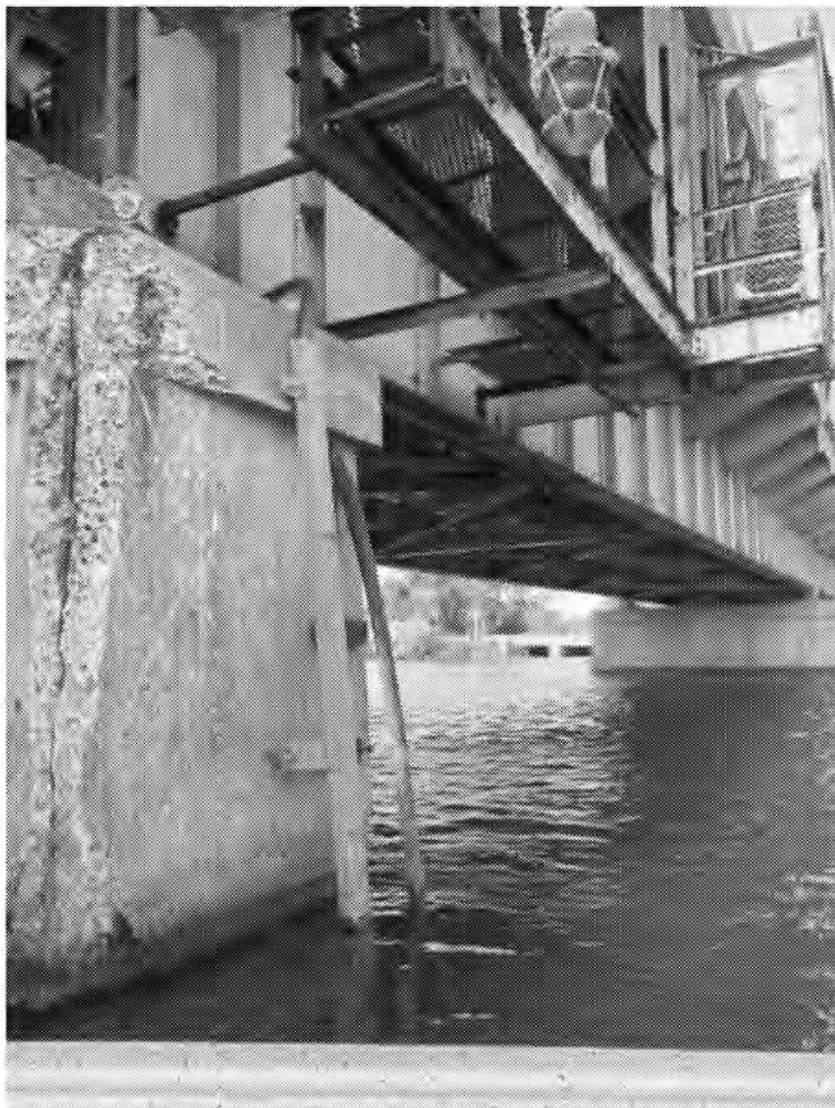
(E) Lead sheathed cable along the Grosse Ile Parkway Bridge. The cable runs through the concrete and is cut just above the ledge. DR 2, Grosse Ile Township, MI

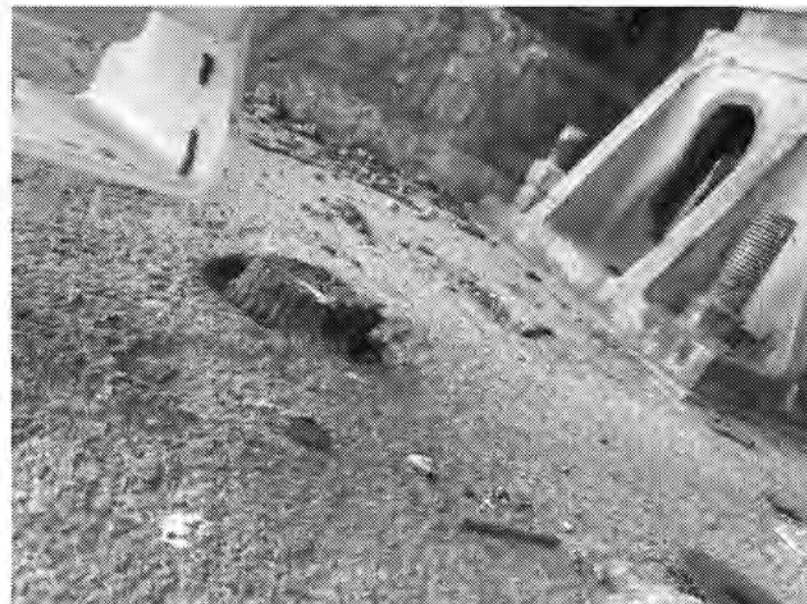
(F) Cut lead sheathed cable, referenced in (E). DR 2, Grosse Ile Township, MI.

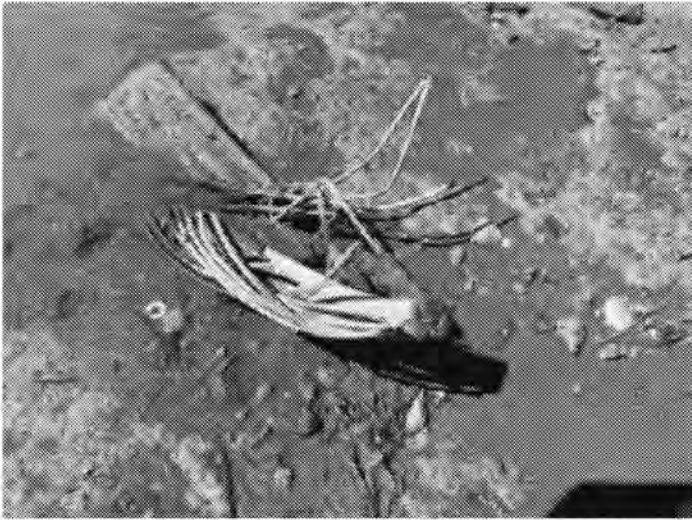
(A) Abandoned lead sheathed cable near Ross Island. WR 1. August 2022, Portland, Oregon.

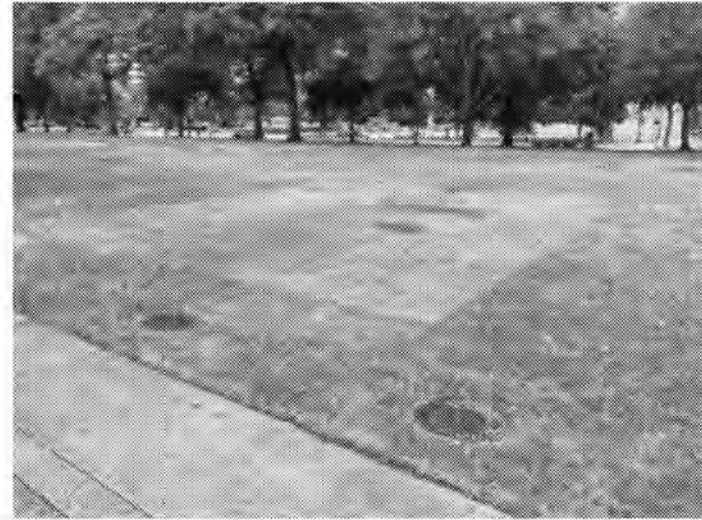
(C) Five Bell Systems manholes with vault. WR 2.2. August 2022, Portland, Oregon.

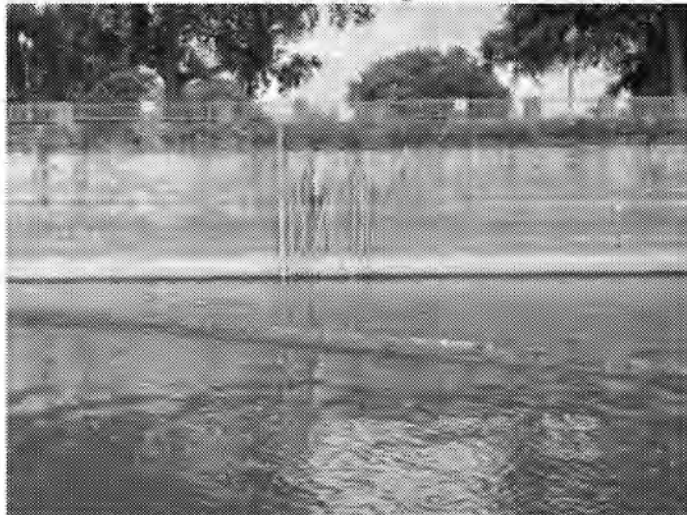
(B) Eleven cables near Maritime Museum and Waterfront Park. WR 2.2. August 2022, Portland, Oregon.

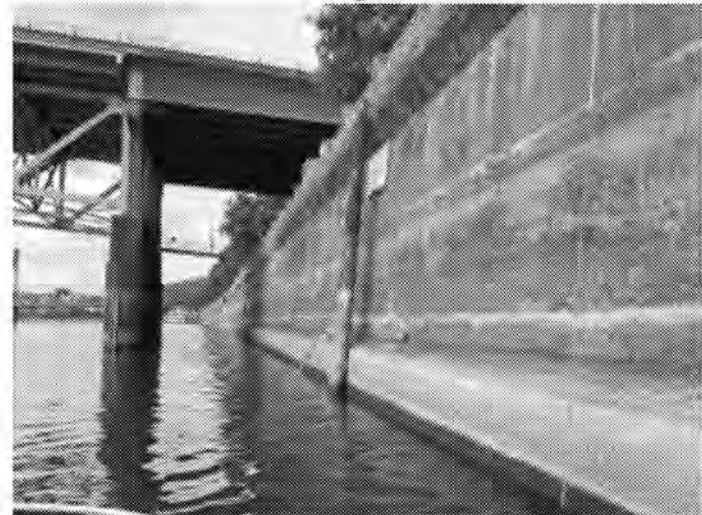
(D) Smaller lead sheathed cable below Western Union Telecom Co. Sign, WR 3. August 2022, Portland, Oregon.

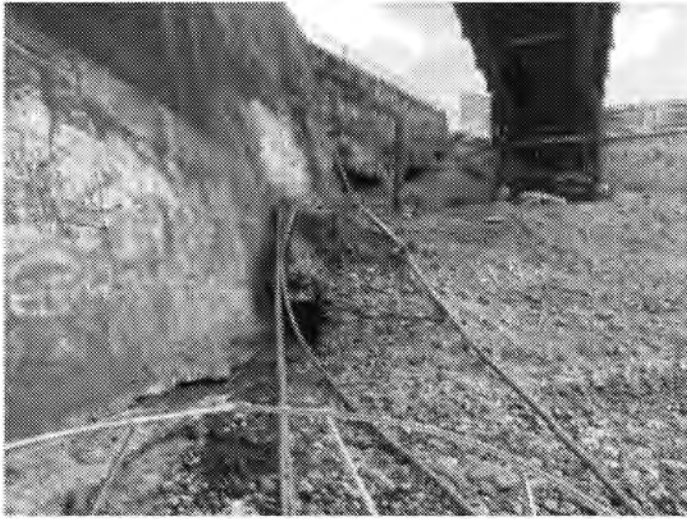
(E) North Steel Bridge cables. WR 6. August 2022, Portland, Oregon.

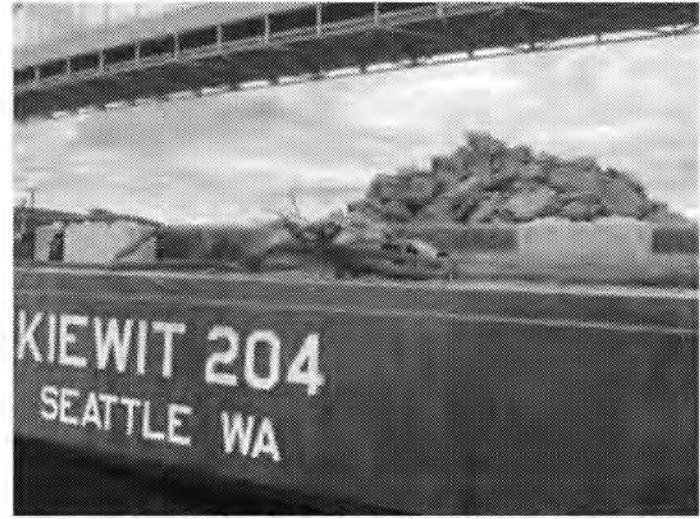
(G) Active construction site. Lead sheathed cable. Kiewit 204. WR 8. August 2022, Portland, Oregon.

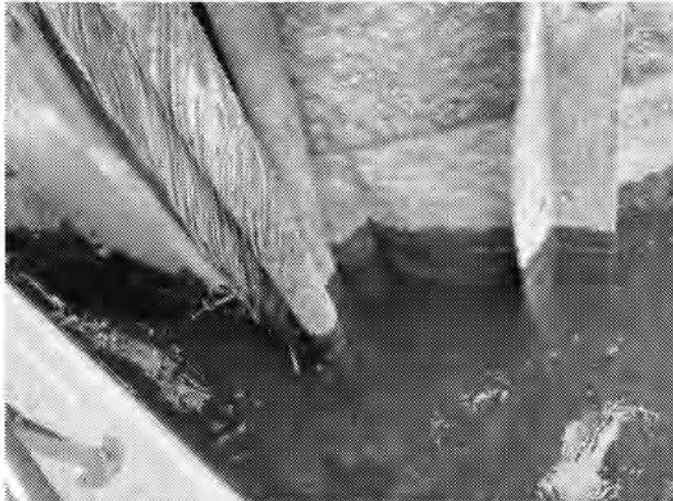
(F) NW Broadway Bridge cables. WR 7. August 2022, Portland, Oregon.

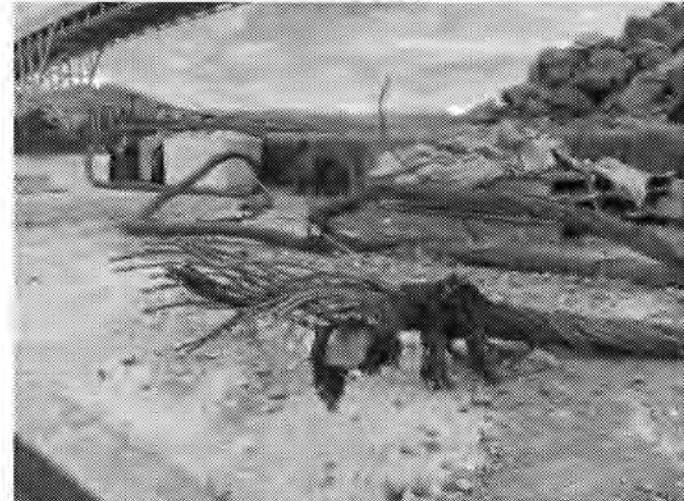
(H) Possible Abernathy Bridge cable. WR 8. August 2022, Portland, Oregon.

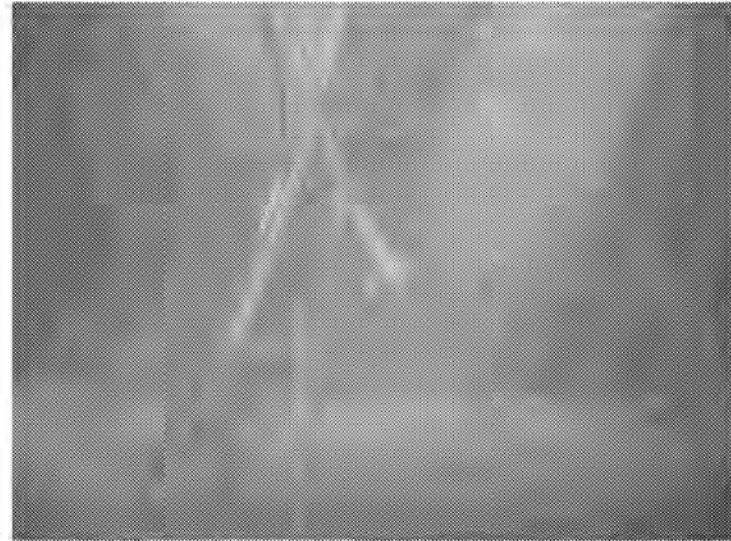
(B) Photo. Lead sheathed cables just below the surface. Site LP 4.1. August 2022, Lake Pend Oreille, ID.

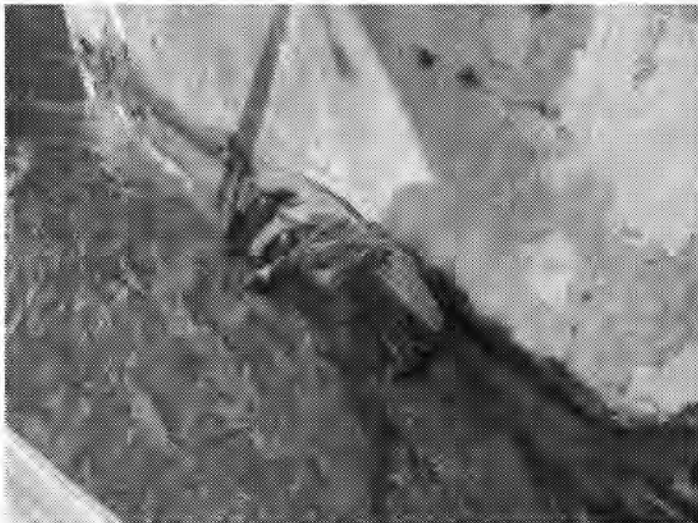
There was one point with visible lead sheathed cables in Idaho that was found in Lake Pend Oreille on the southeast end of the railroad bridge near Highway 95. This collection of cables was cut and left in place at the base of the bridge. At the time of our most recent visit, there was construction work and a large barge over the location of the cables which are tangled underwater. Refer to Figure 15A-D and Figure 16E-G for Lake Pend Oreille photos.

(C) Lead sheathed cables cut and hanging from bridge. Site LP 4.1. August 2022, Lake Pend Oreille, ID.

Overall, our findings in Idaho showed few visible lead sheathed cables with a high potential of buried cables in areas where signs and Bell Systems manholes were observed. The cables found off the old railroad bridge have been cut and left near the base of the bridge. They are clearly abandoned and should be removed. Further investigation into the status of these cables and how to move forward with the next steps of removing the remnants is suggested.

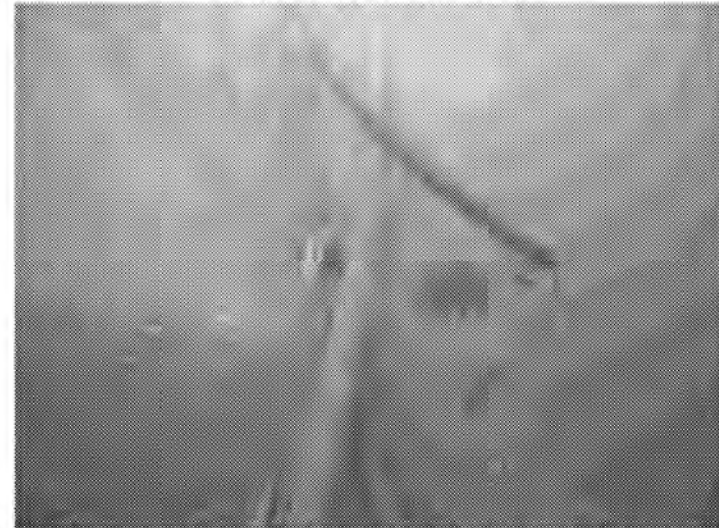
(D) Bare lead (top right). Cut end, near fish (mid-left). Site LP 4.1. August 2022, Lake Pend Oreille, ID.

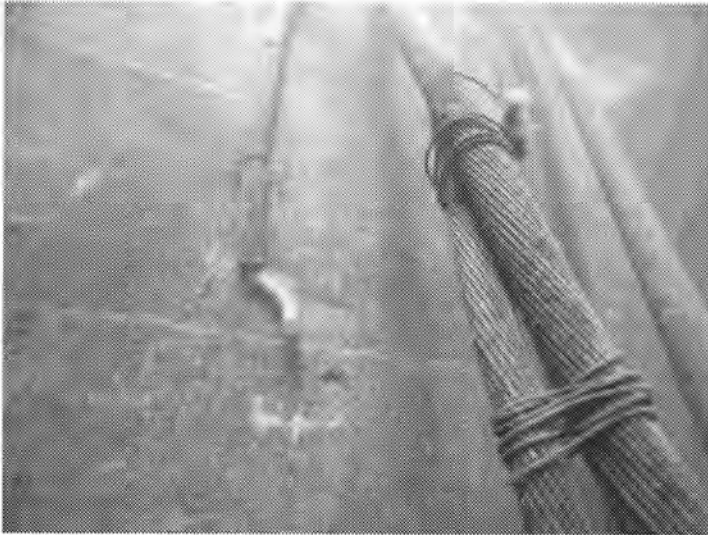
(E) Close up of cut, bare lead sheathed cable underwater. Site LP 4.1. August 2022, Lake Pend Oreille, ID.

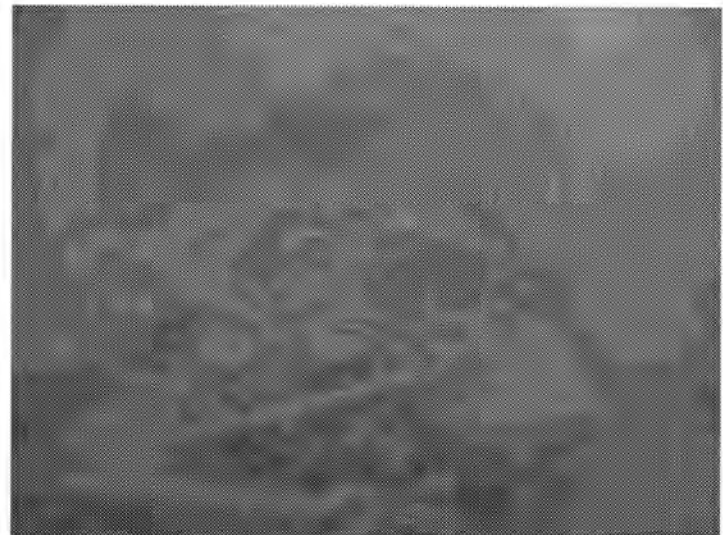
(F) Lead sheathed cables abandoned and coiled below the surface. Site LP 4.1. August 2022, Lake Pend Oreille, ID.

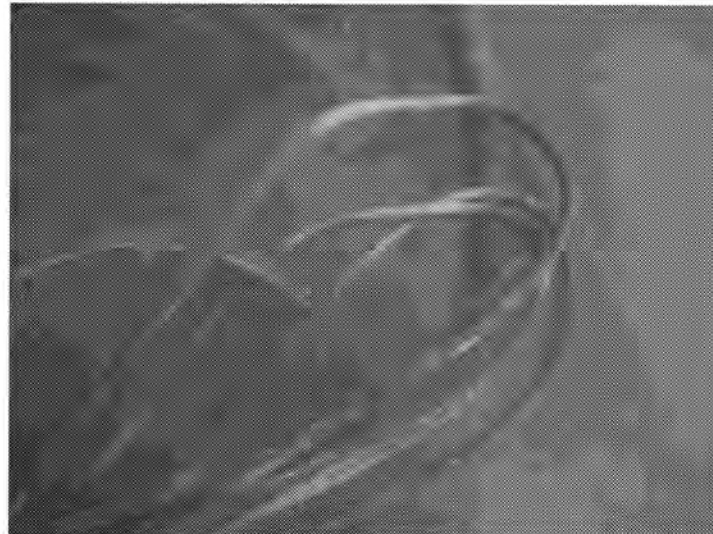
(G) Close up of bare lead from abandoned cables. Site LP 4.1. August 2022, Lake Pend Oreille, ID.

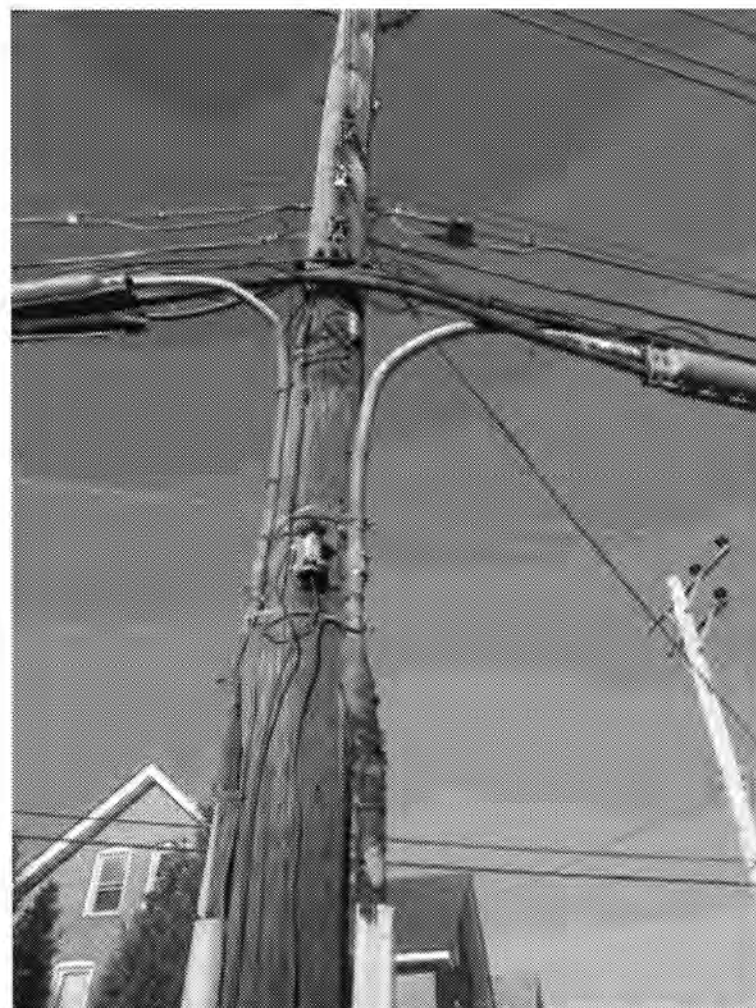
(C) Close up of lead sheathed cable and splice boxes referenced in (A). October 2022. Natrona, Pennsylvania.

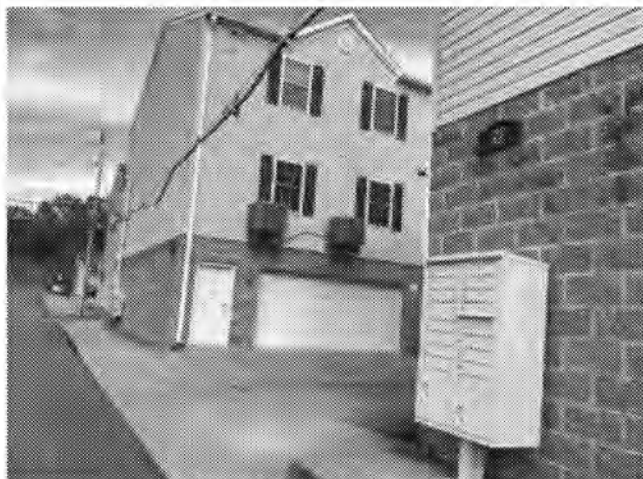
(D) CT6. Overhead lead sheathed cable running across the entrance into apartments and over access to mailboxes. February 2023. Coal Center, Pennsylvania.

townships may have similar overhead cables that should be explored. Recommend further investigations.

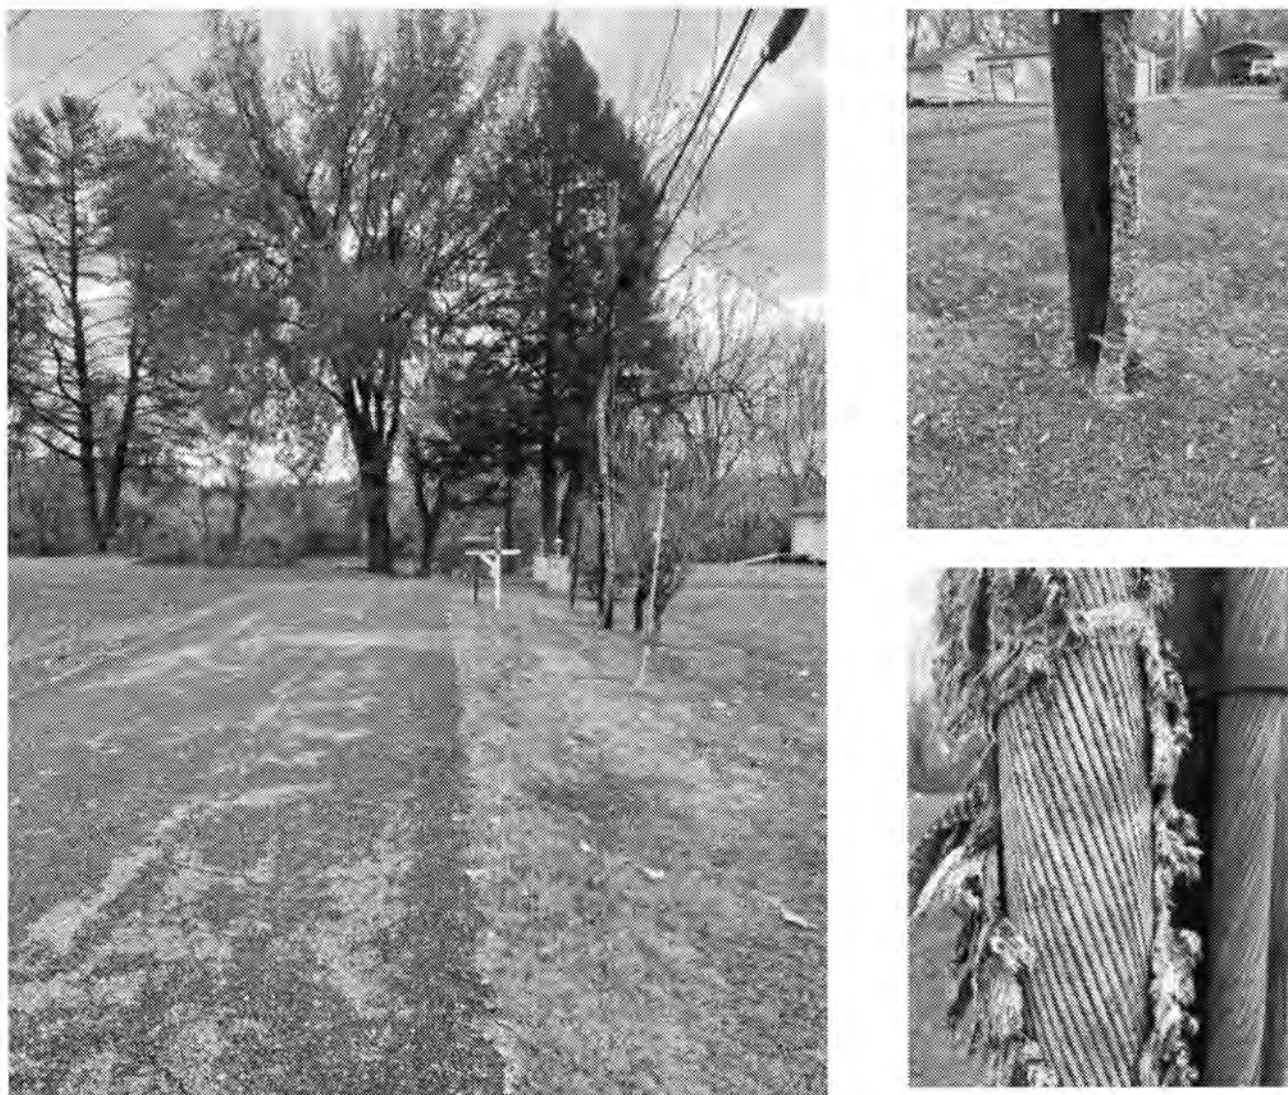
Figure 19. Photos taken in West Virginia. Site for the Old Pliny Ferry Crossing at Frasier's Bottom. Two bare lead sheathed cables were observed at the end of Ferry Lane. KR 1.3. October 2022, Pliny, West Virginia.
